A 1 Professional Home Inspection  
14 Brevoort Pl.  
Deer Park, NY 11729

Jamaica, NY 11434

# A 1 Professional Home Inspection

Inspection Date 02/17/2009

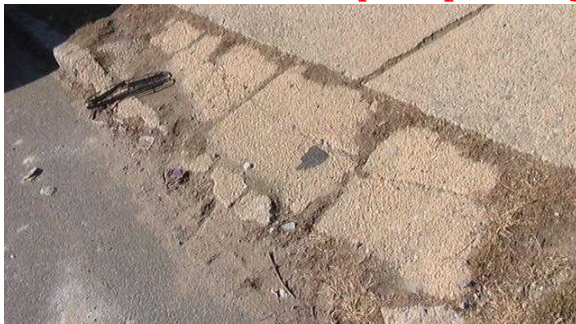
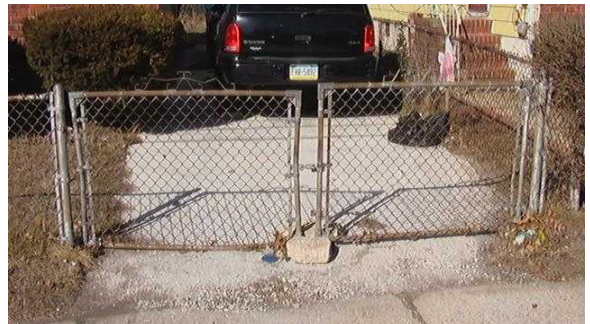
1. Unsatisfactory Driveway: driveway skirt has settlement damage - driveway also has settlement - driveway is pitching towards home

<u>Low</u>	<u>High</u>
<u>Lots and Grounds</u>		
Driveway: install new driveway and pitch water away from home - including new skirt	\$ 6500	\$ 6500
Steps Replace steps - Major settlement damage	\$ 2500	\$ 2500
Steps Replace steps - Major settlement damage	\$ 2500	\$ 2500
<u>Exterior Surface and Components</u>		
Type: seal front brink veneer to home - replace all exterior shingles	\$ 6500	\$ 6500
Windows: replace windows	\$ 5500	\$ 5500
<u>Roof/Chimney</u>		
Material: replace roof and underlayment - install attic fan	\$ 10000	\$ 10000
Gutters: secure and replace defective gutters as needed	\$ 2500	\$ 2500
<u>Electrical</u>		
Service: install new entrance cable - and conduit	\$ 2500	\$ 2500
Manufacturer: Replace Electric Panel	\$ 1500	\$ 1500
<u>Basement</u>		
Walls: Mold present-potential health concern-needs removal/correction - remove all mold damaged wall material and install new	\$ 8500	\$ 8500
<u>Plumbing</u>

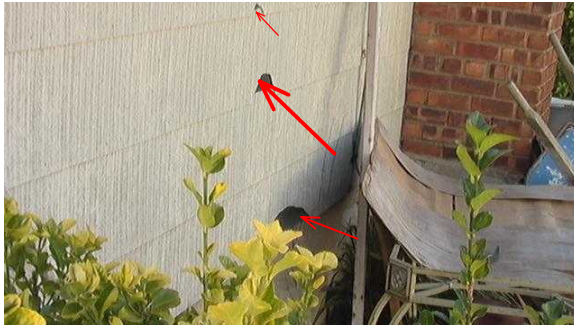
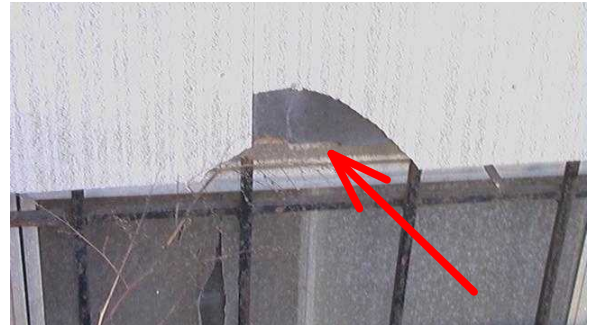
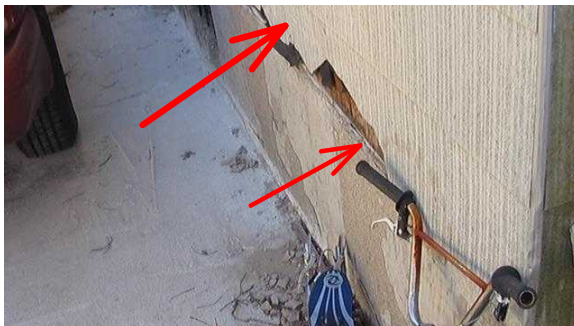
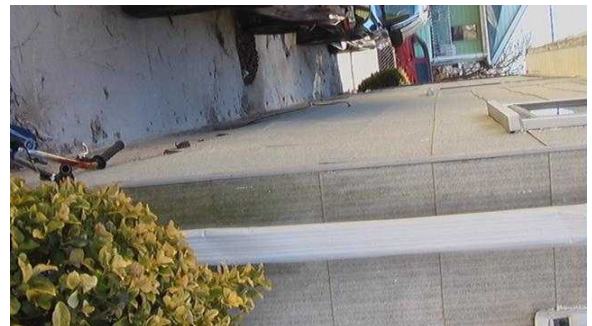
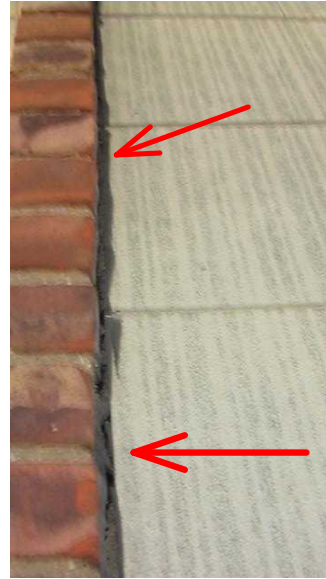
2. Unsatisfactory Type: Asbestos Shingles **asbestos shingles are loose and damaged, water is getting into home ..**

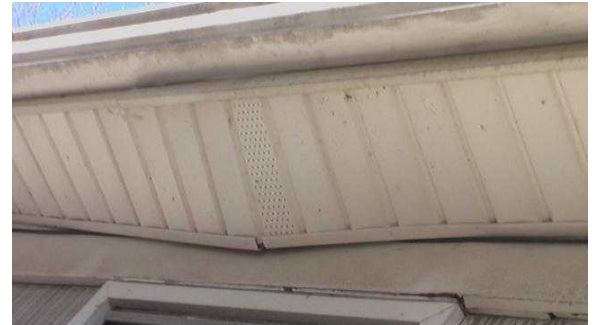
3. Unsatisfactory Soffits: Vinyl Loose

<u>Low</u>	<u>High</u>
<u>Exterior Surface and Components</u>		
Soffits: repair loose soffits	\$ 1000	\$ 1000
<u>Roof/Chimney</u>		
Chimney: Repair Major Damage to Chimney, Flue, and footing	\$ 7500	\$ 7500
Flue/Flue Cap: install chimney cap	\$ 450	\$ 450
<u>Electrical</u>		
GFCI: install GFCI outlets in home	\$ 1200	\$ 1200
<u>Structure</u>		
Differential Movement: repair damage to northeast basement wall - due to hydrostatic pressure	\$ 15000	\$ 15000
North Exerior Wall: repair bow out wall, and water damage	\$ 4500	\$ 4500
<u>Attic</u>		
Ventilation: install attic fan	\$ 1200	\$ 1200
<u>Basement</u>		
Floor: install new flooring in basement	\$ 2500	\$ 2500
<u>Heating System</u>		
Heating System Operation: Replace heating system	\$ 6500	\$ 6500
<u>Bathroom</u>		
Tub/Surround: replace tub	\$ 1200	\$ 1200
Shower Body: replace shower body	\$ 1500	\$ 1500
Walls: repair walls and install new tub surround	\$ 3500	\$ 3500

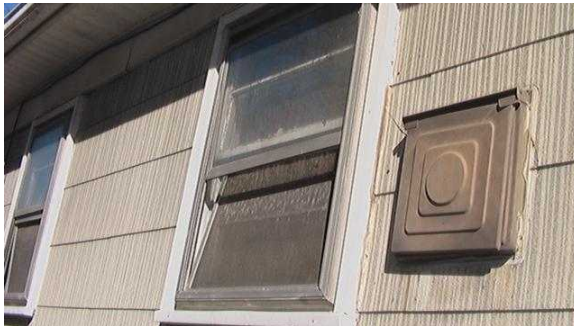
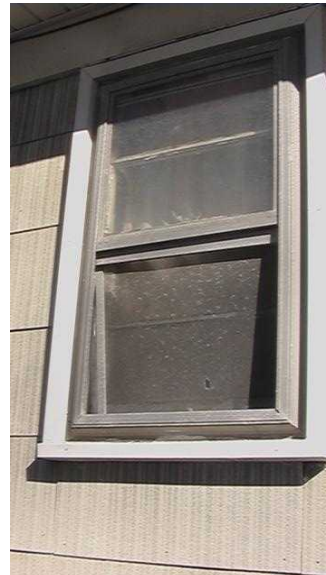
4. Unsatisfactory Windows: Wood double hung Cracked, broken or missing glass, windows are beyond their life span - all windows are leaking water thru inner walls

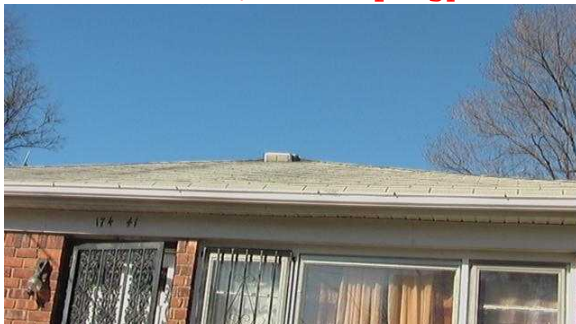
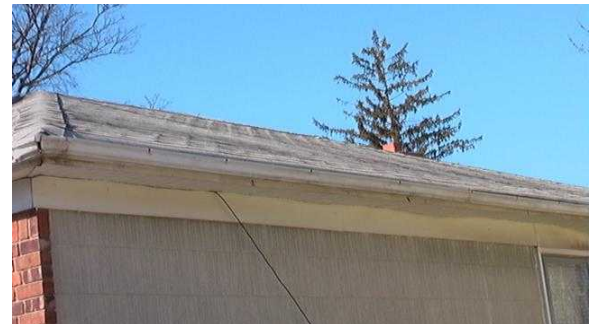
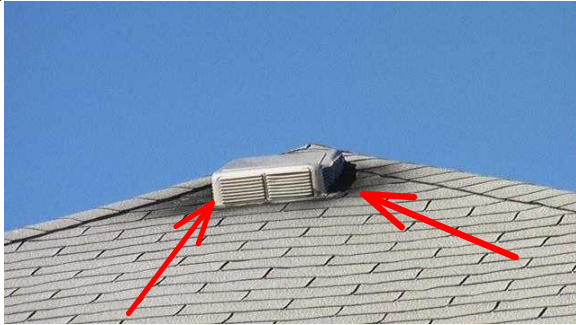
2. Unsatisfactory Material: Asphalt shingle Roof existing beyond design life, Shingles nailed improperly, Roof at end of useful life, Roof shows signs of deterioration, Roof spongy to walk on

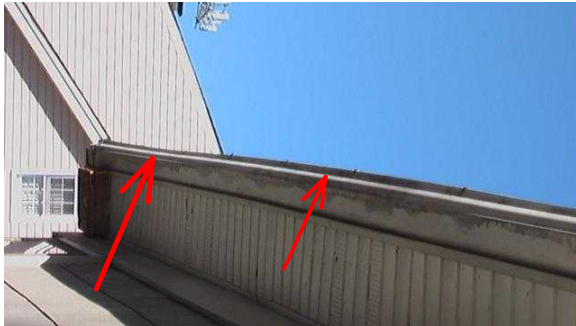
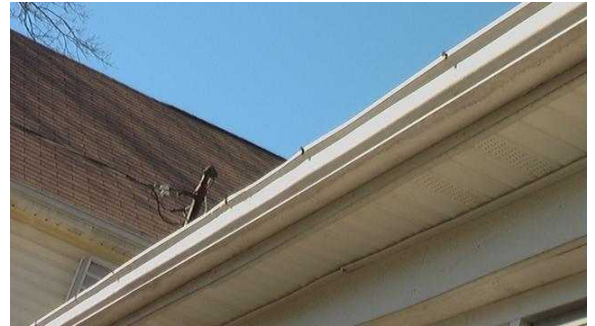
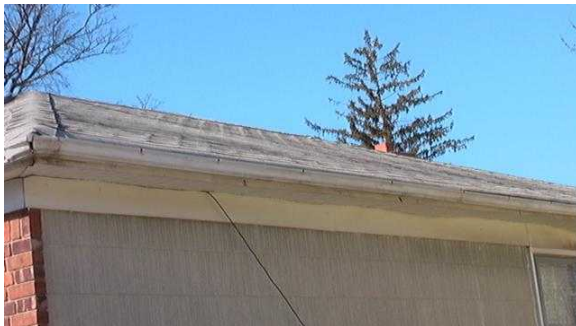
6. Unsatisfactory Gutters: Aluminum Gutters have negative flow and are holding water, Gutters loose, spikes or straps missing, Loose nails

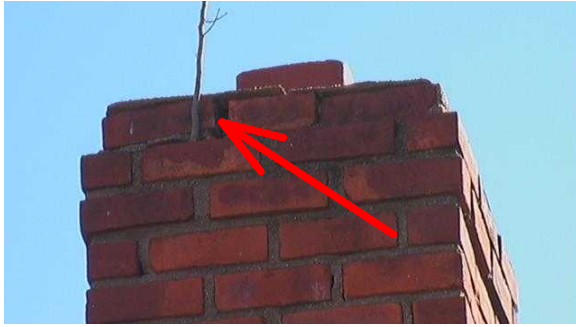
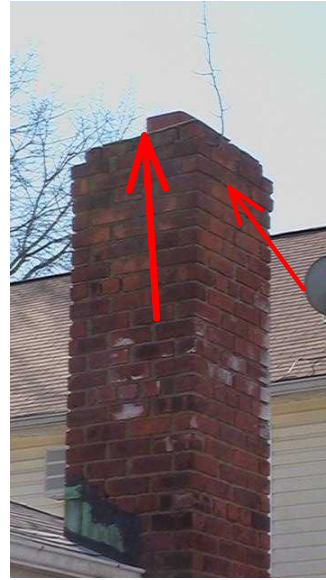
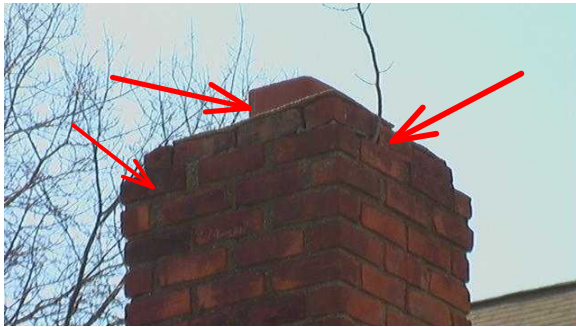
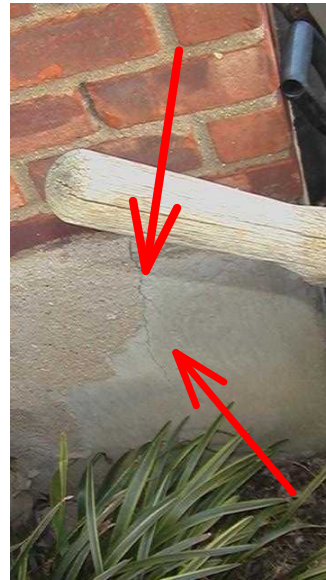
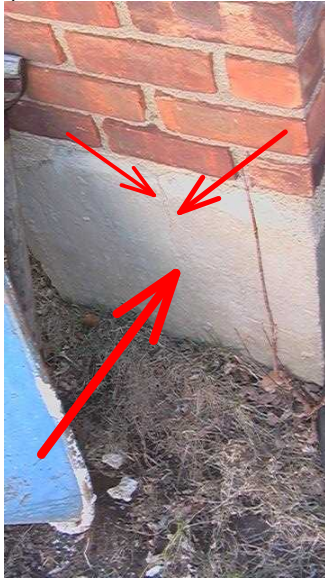
Rear of Home Chimney

7. Unsatisfactory Chimney: Brick Chimney requires tuck point repairs, Bricks have broken or popped surfaces- repairs required - Chimney footing is damaged from settlement

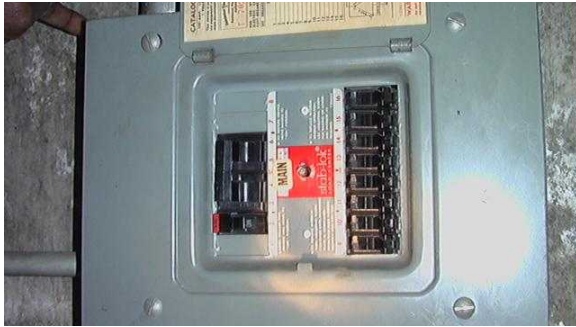
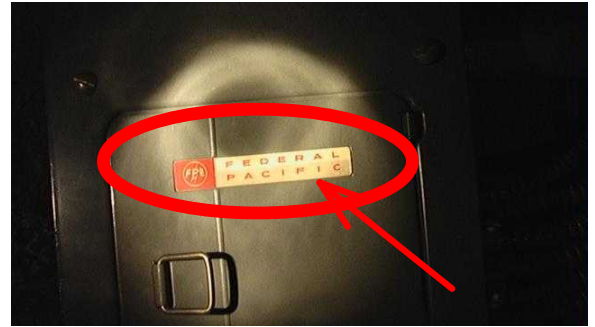
6. Unsatisfactory Manufacturer: Federal Pacific Federal Pacific panel breakers have a history of not tripping when circuit overloading exists

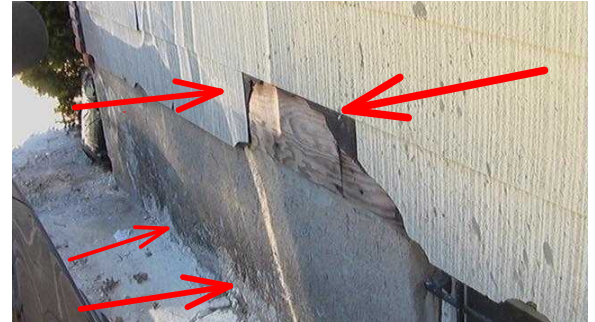
1. Unsatisfactory Water Damage Extensive Extensive water damage noted thru out the home  
2. Unsatisfactory Differential Movement: North East Wall Hydrostatic pressure is pushing into basement wall 3 feet down and causing basement wall to push wall to bow out first floor wall.

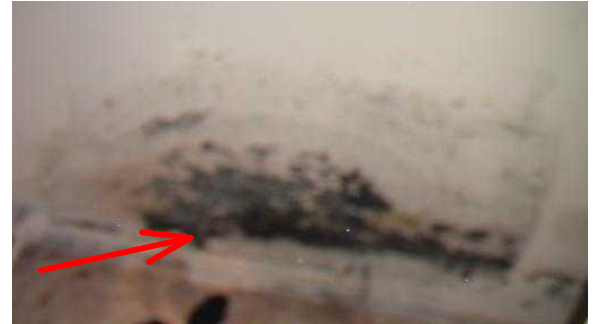
1. Unsatisfactory Ceiling:
2. Unsatisfactory Walls: Mold present-potential health concern-needs removal/correction

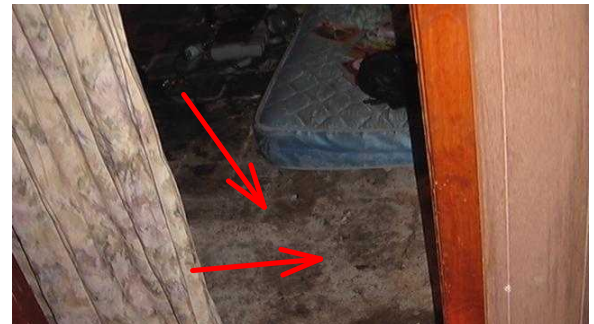
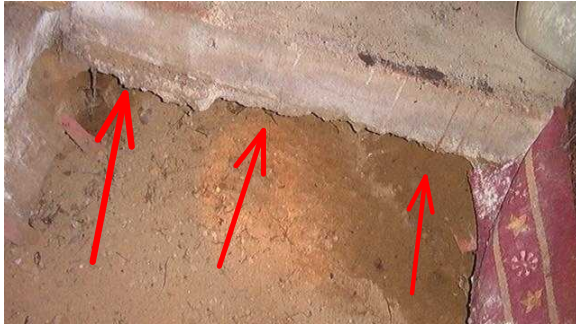
3. Unsatisfactory Floor: major water damage present , mold present - dirt under basement floor has wash away due to the sewer trap open caps. the basement floor is floating and needs support

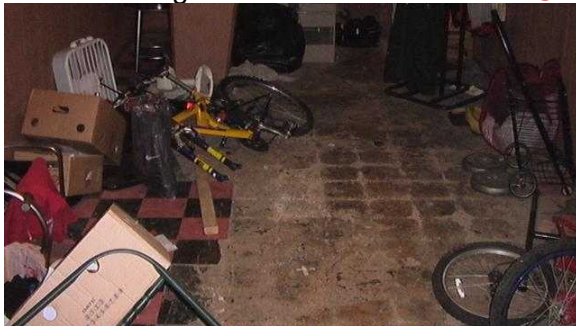
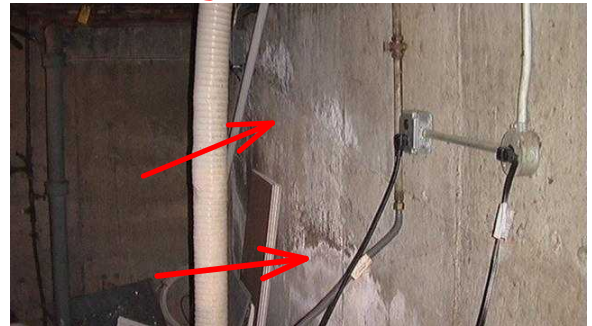
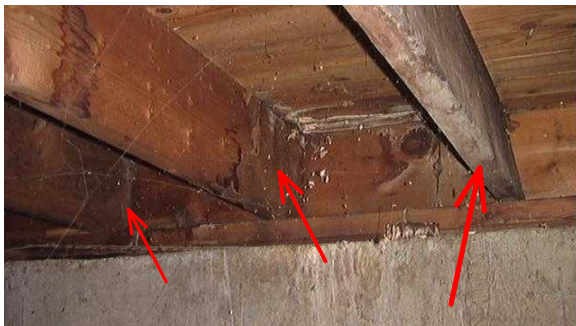
4. Unsatisfactory Water Damage: entire basement major water damage in basement

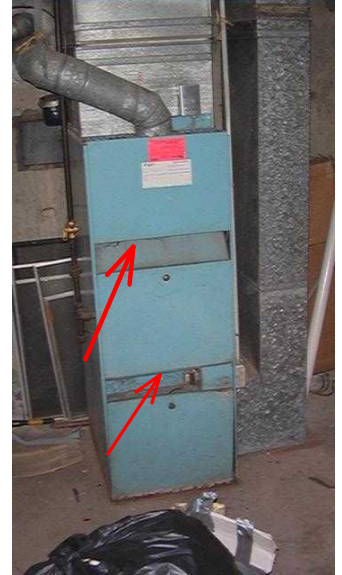
2. Unsatisfactory Heating System Operation: Inadequate, REPLACEMENT NEEDED  
Furnace existing beyond design life

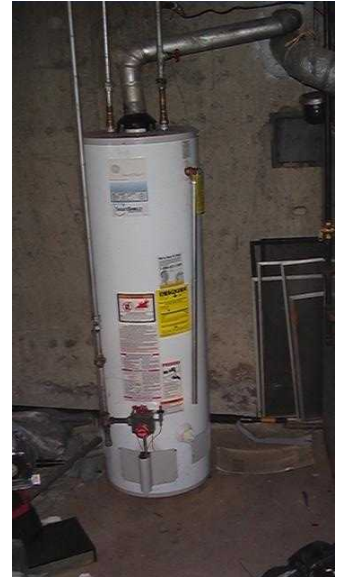
2. Unsatisfactory Water Heater Operation: Inadequate Evidence of past or present water leakage in drain tube from pressure relief valve, Flue pipe backdrafting, Water heater is nearing the end of it's design life

Water Heater Operation: replace hot water heater	\$ 900	\$ 900
	<b>Replacement Total</b>	<b>\$ 49400</b>

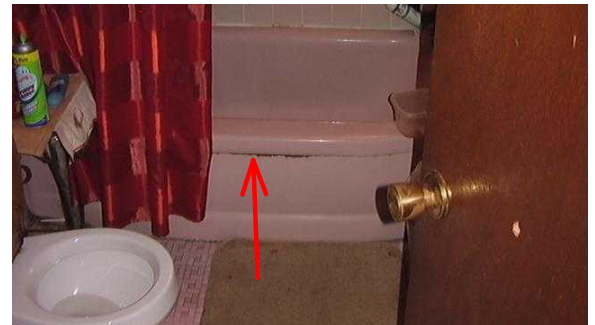
1. Unsatisfactory Tub/Surround: Porcelain tub **replace rusted tub**

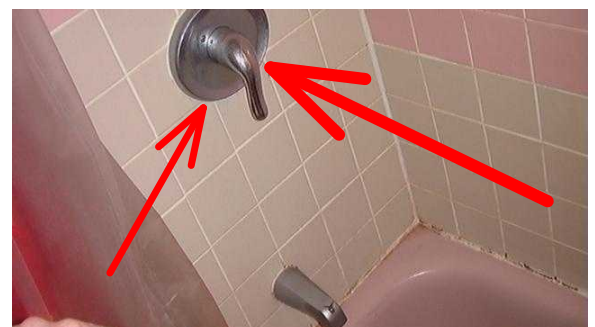
2. Unsatisfactory Shower Body: **leaking shower body**

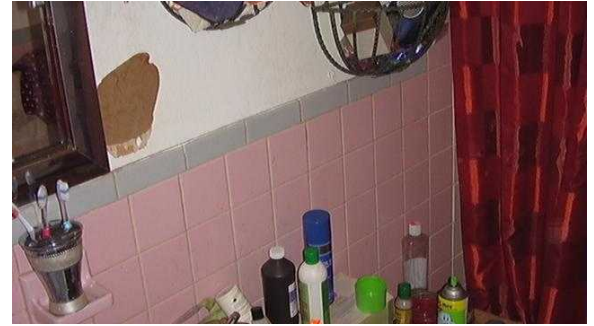
3. Unsatisfactory Walls: **damaged walls in bath**

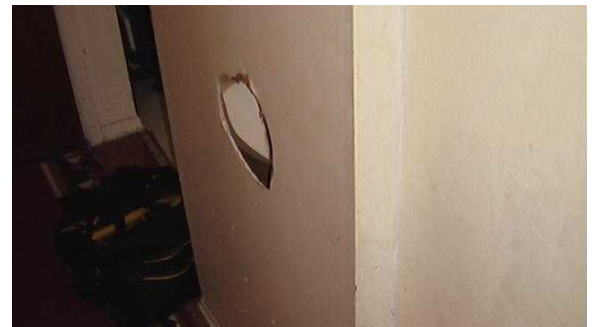
1. Unsatisfactory Walls: sheet rock **damaged wall thru out home ...**

<u>Living Space</u>		
Walls: repair damage sheet rock	\$ 3500	\$ 3500
	<b>Repair Total</b>	<b>\$ 49550</b>

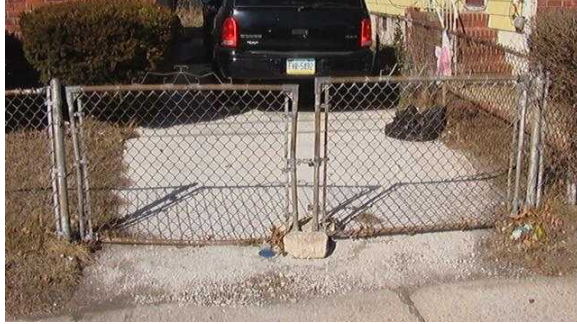
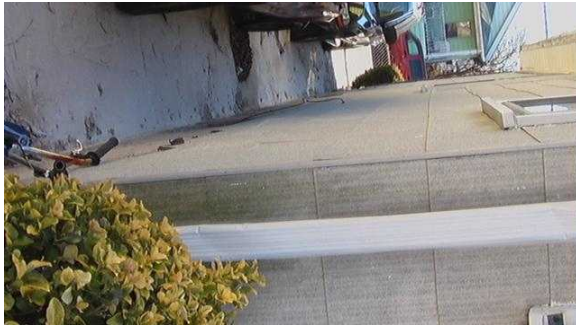
1. Driveway: driveway skirt has settlement damage - driveway also has settlement - driveway is pitching towards home

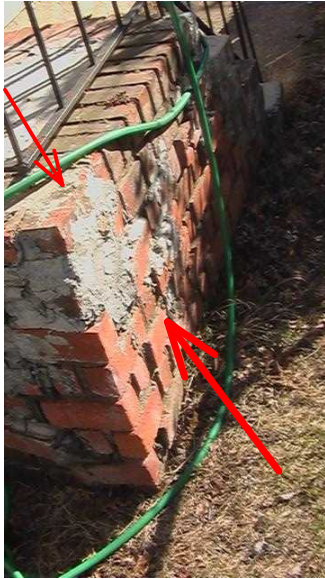
3. Side of home Steps To Building Steps brick major settlement

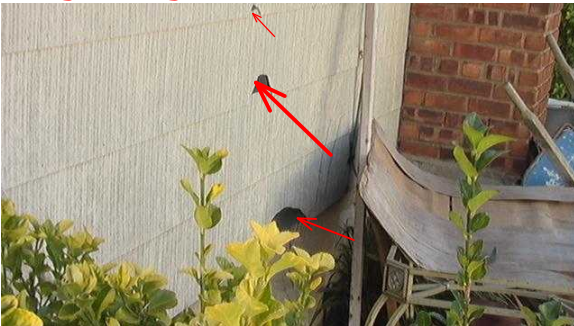
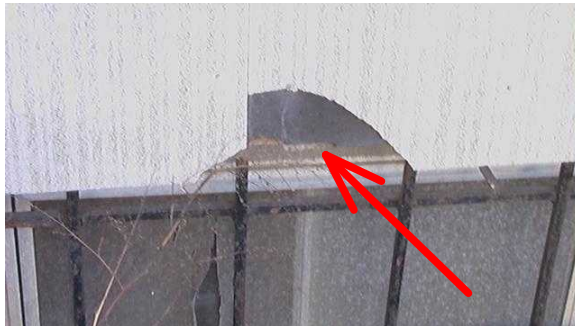
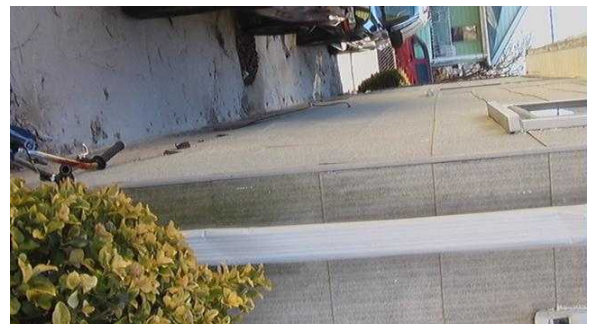
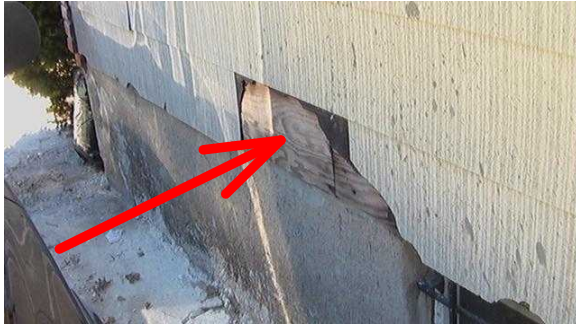
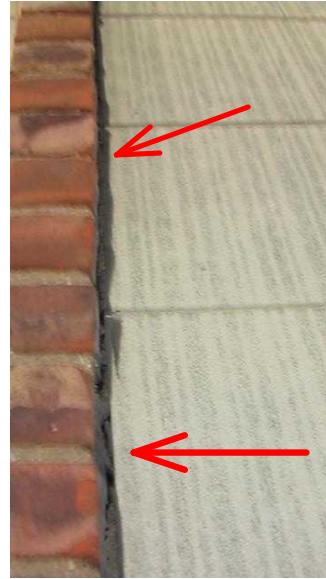
4. Front Exterior Surface Type: Brick veneer
5. Exterior Surface Type: Asbestos Shingles *asbestos shingles are loose and damaged, water is getting into home ..*

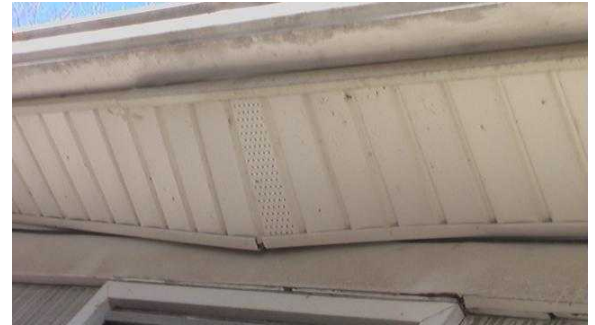
6. Soffits: Vinyl Loose

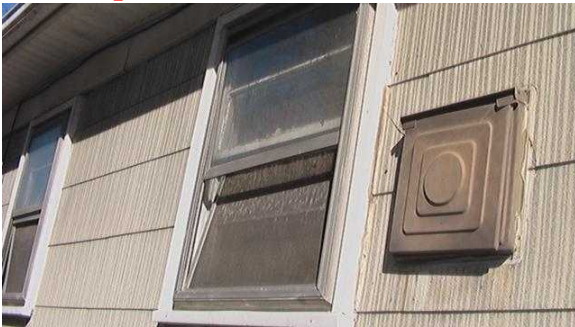
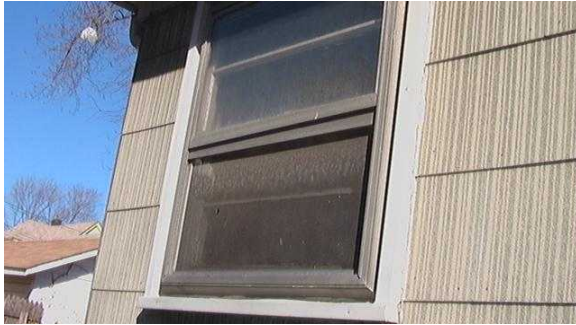
7. Windows: Wood double hung Cracked, broken or missing glass, windows are beyond there life span - all windows are leaking water thru inner walls

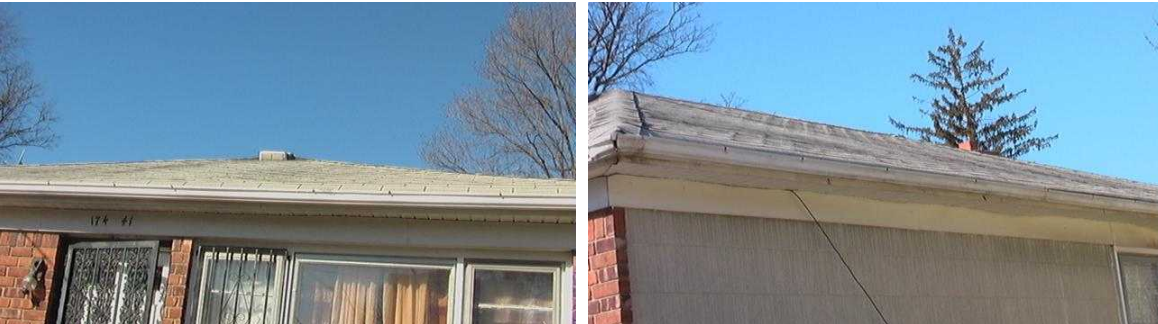
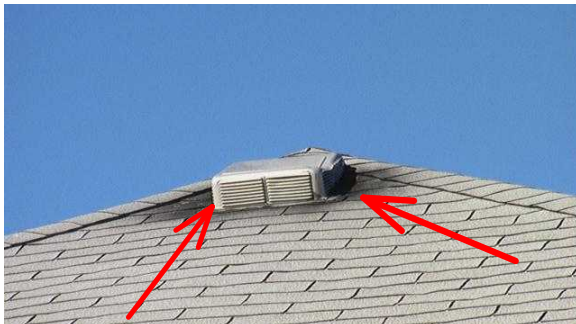
8. Main Roof Surface Material: Asphalt shingle Roof existing beyond design life, Shingles nailed improperly, Roof at end of useful life, Roof shows signs of deterioration, Roof spongy to walk on

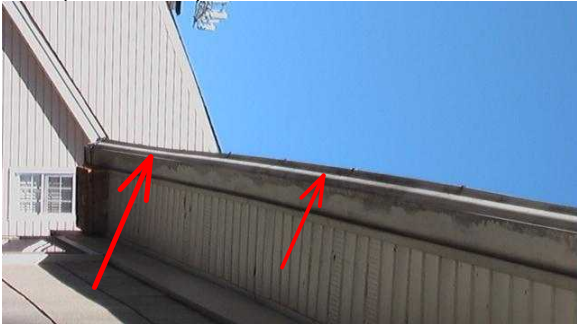
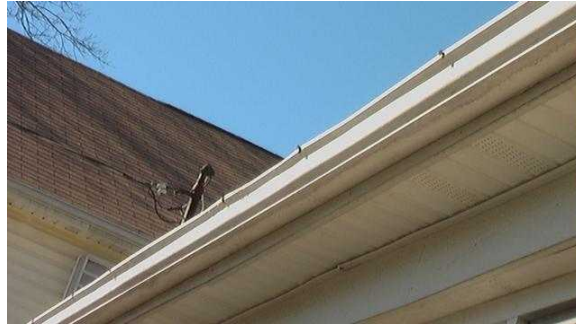
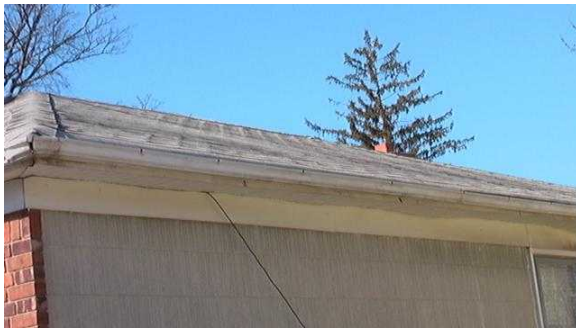
9. Flashing: Aluminum Improper installation  
10. Electrical Mast: Weather head not properly secured  
11. Gutters: Aluminum Gutters have negative flow and are holding water, Gutters loose, spikes or straps missing, Loose nails

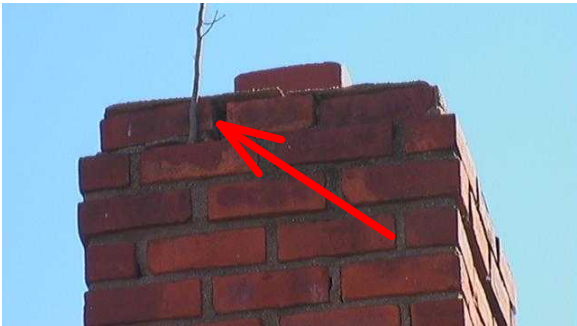
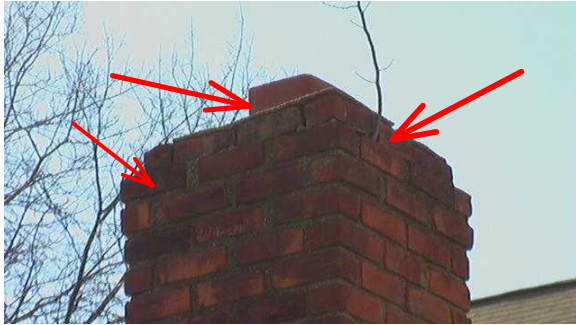
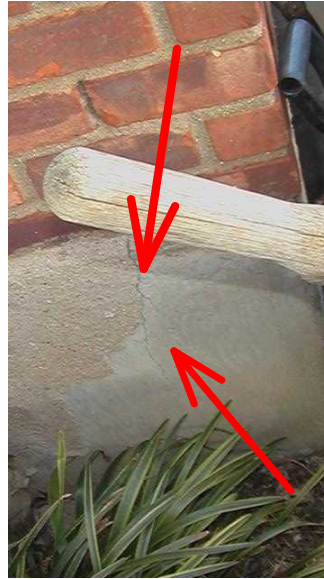
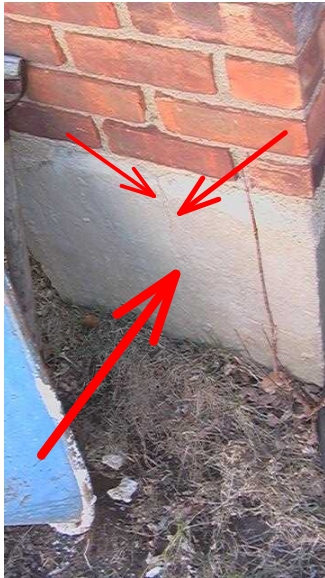
12. Rear of Home Chimney: Brick Chimney requires tuck point repairs, Bricks have broken or popped surfaces- repairs required - Chimney footing is damaged from settlement

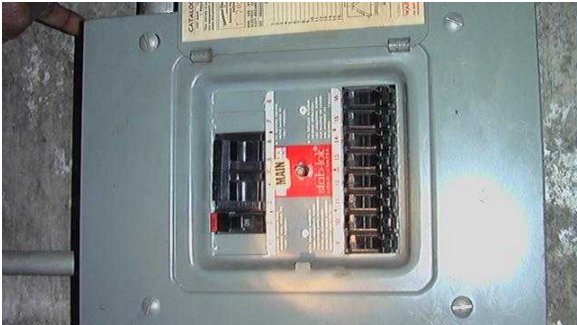
16. Electric Panel Manufacturer: Federal Pacific Federal Pacific panel breakers have a history of not tripping when circuit overloading exists

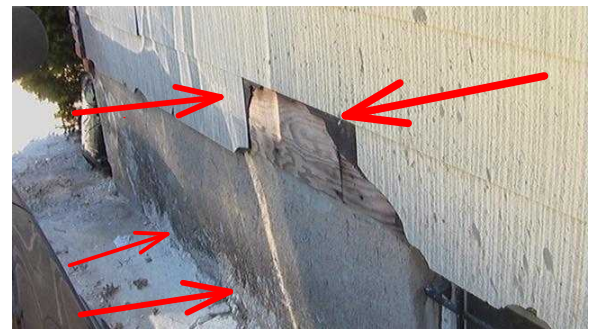
19. Water Damage Extensive Extensive water damage noted thru out the home  
20. Differential Movement: North East Wall Hydrostatic pressure is pushing into basement wall 3 feet down and causing basement wall to push wall to bow out first floor wall.

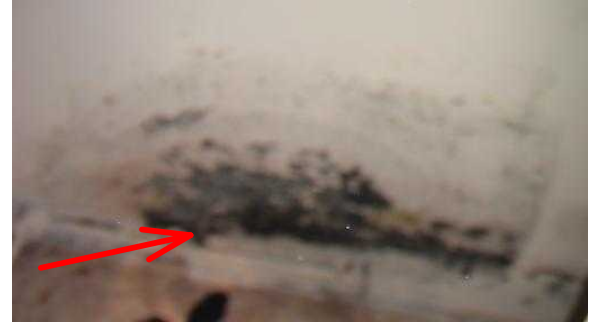
24. Main Basement Walls: **Mold present-potential health concern-needs removal/correction**

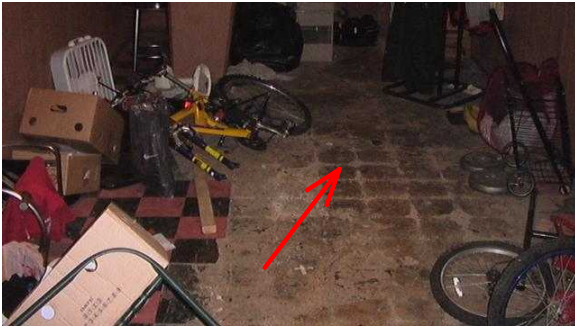
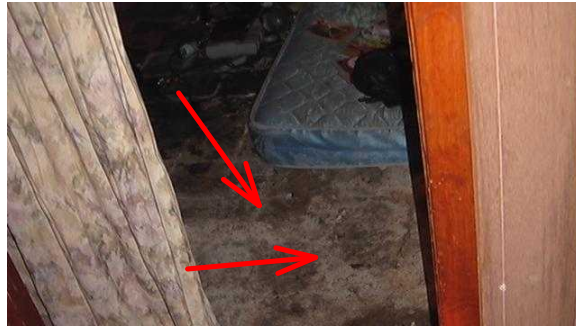
25. Main Basement Floor: **major water damage present , mold present - dirt under basement floor has wash away due to the sewer trap open caps. the basement floor is floating and needs support**

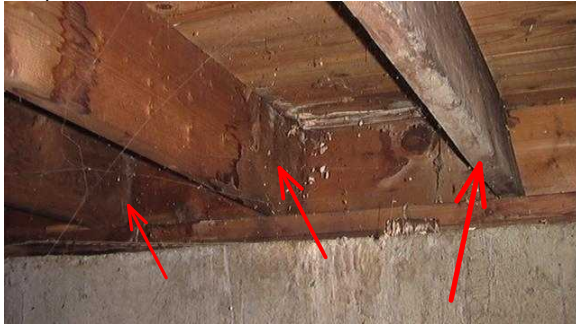
26. Main Basement Water Damage: **entire basement major water damage in basement**

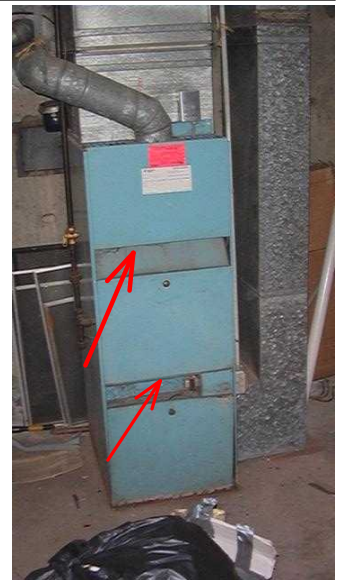
27. Basement Heating System Heating System Operation: Inadequate, REPLACEMENT NEEDED **Furnace existing beyond design life**

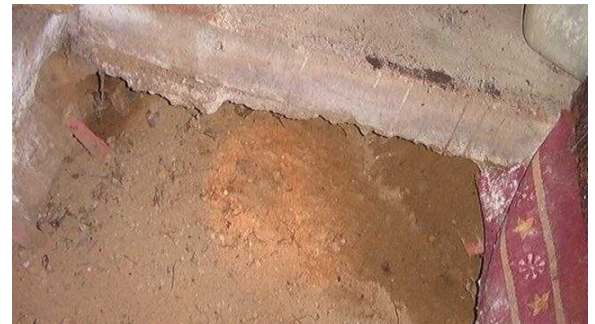
31. Sewer Trap: **sewer trap is covered by dirt - clear dirt away from sewer trap ..**

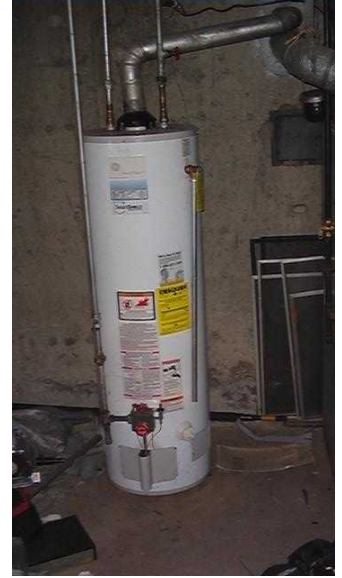
32. Water Heater Water Heater Operation: Inadequate Evidence of past or present water leakage in drain tube from pressure relief valve, Flue pipe backdrafting, Water heater is nearing the end of it's design life

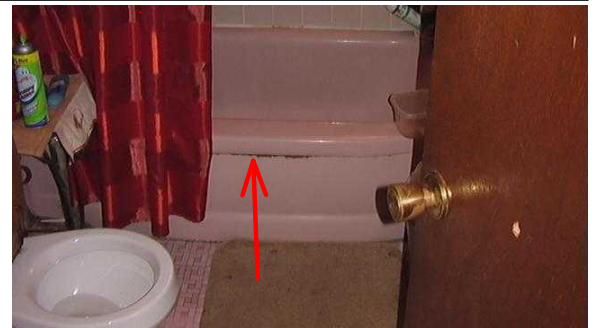
33. 1st floor main Bathroom Tub/Surround: Porcelain tub **replace rusted tub**

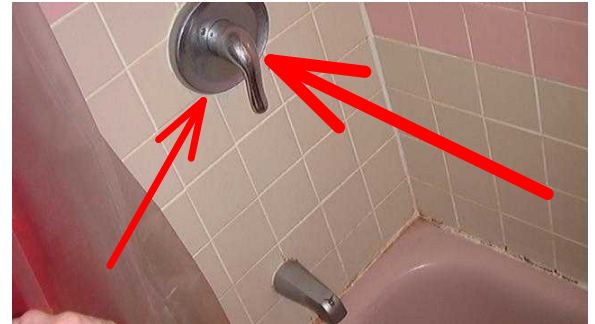
34. 1st floor main Bathroom Shower Body: **leaking shower body**

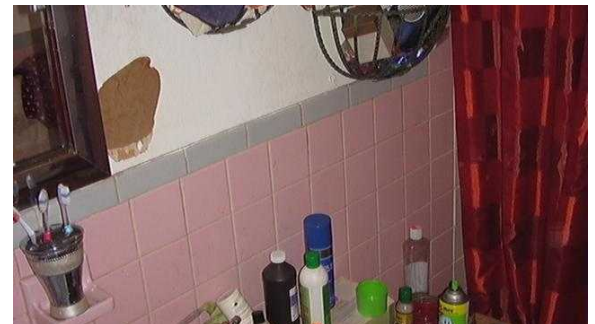
35. 1st floor main Bathroom Walls: **damaged walls in bath**

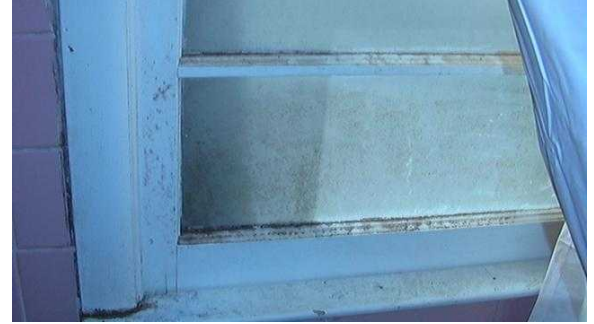
36. 1st floor main Bathroom Windows: Wood double hung **Painted shut**

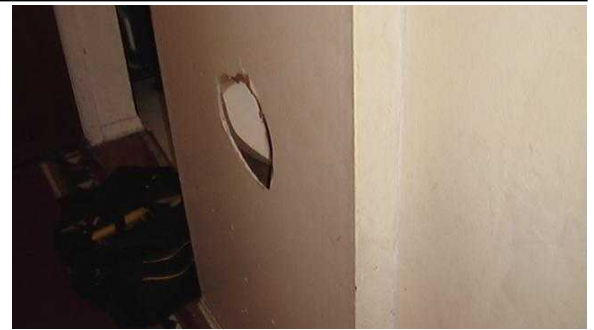
37. Living Space Walls: sheet rock **damaged wall thru out home ...**
