A 1 Professional Home Inspection  
14 Brevoort Pl.  
Deer Park, NY 11729

Jamaica, NY 11434

# A 1 Professional Home Inspection

Inspection Date 02/17/2009

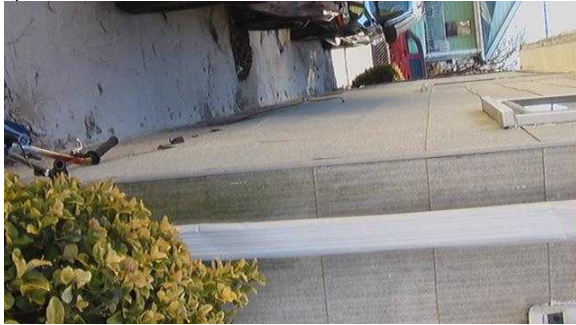
Driveway: (continued)

1. Unsatisfactory Driveway: driveway skirt has settlement damage - driveway also has settlement - driveway is pitching towards home

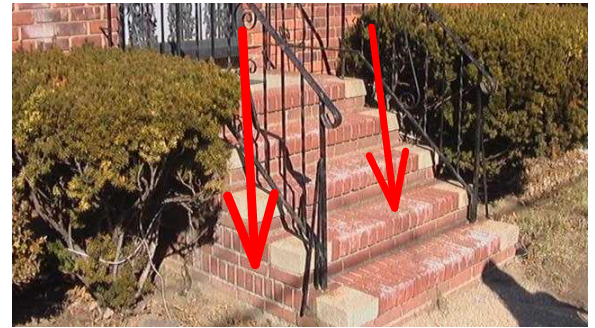
Front of home Steps To Building

2. Unsatisfactory Steps brick major settlement

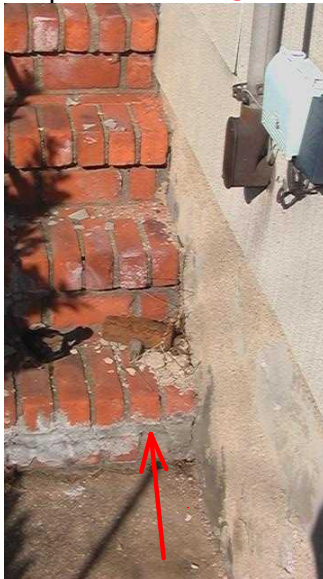
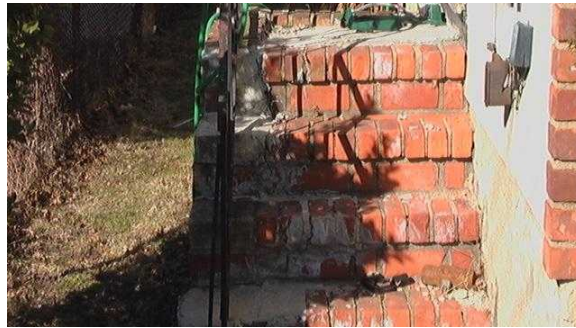
Side of home Steps To Building

3. Unsatisfactory Steps brick major settlement

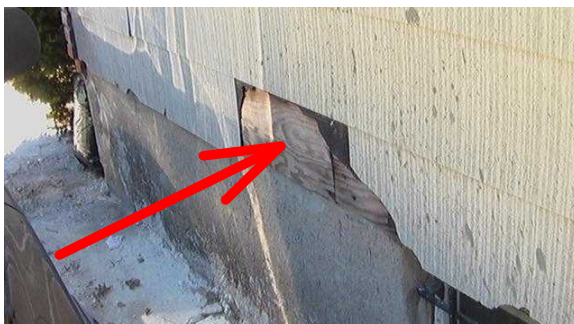
2. Unsatisfactory Type: Asbestos Shingles **asbestos shingles are loose and damaged, water is getting into home ..**

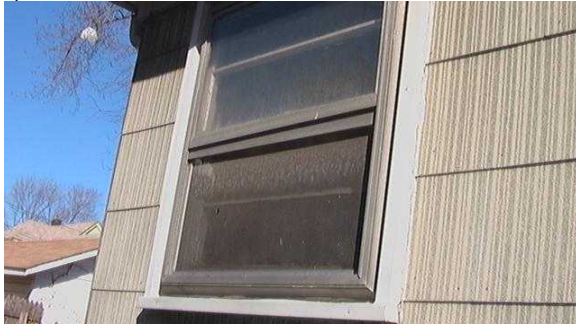
Windows: (continued)

4. Unsatisfactory Windows: Wood double hung Cracked, broken or missing glass, windows are beyond their life span - all windows are leaking water thru inner walls

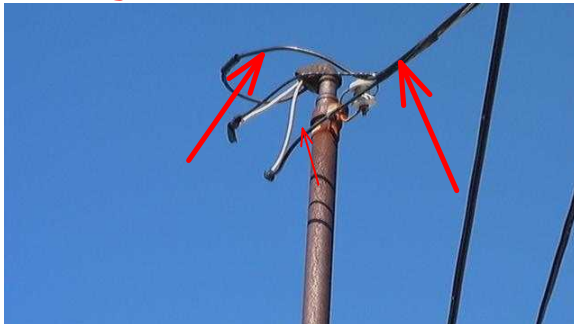
2. Unsatisfactory Service: Aluminum **weather head is pulling away from home ... water is leaking into electric box thru conduit**

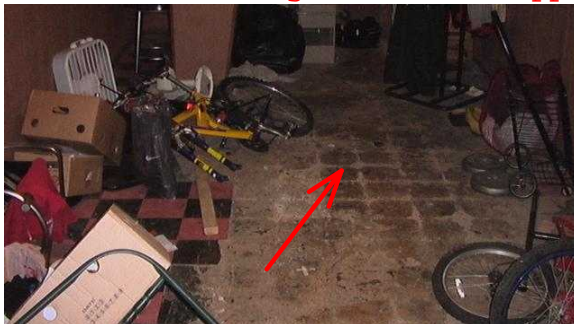
3. Unsatisfactory Floor: major water damage present , mold present - dirt under basement floor has wash away due to the sewer trap open caps. the basement floor is floating and needs support

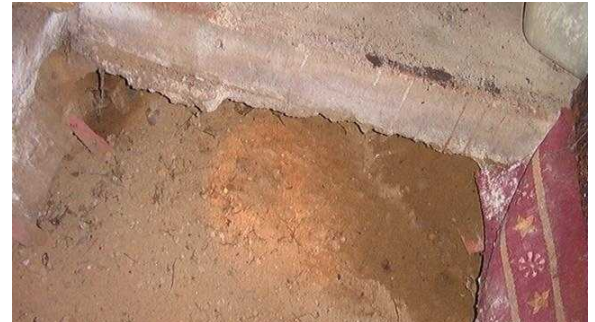
1. Unsatisfactory Sewer Trap: sewer trap is covered by dirt - clear dirt away from sewer trap ..

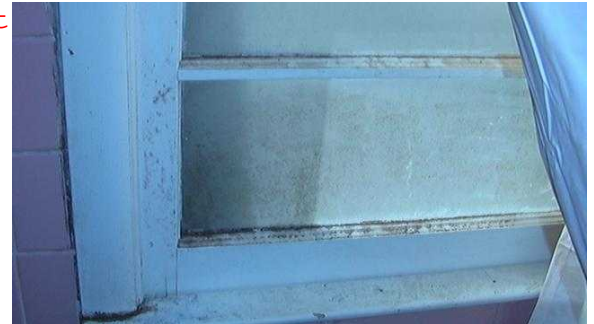
4. Unsatisfactory Windows: Wood double hung **Painted shut**

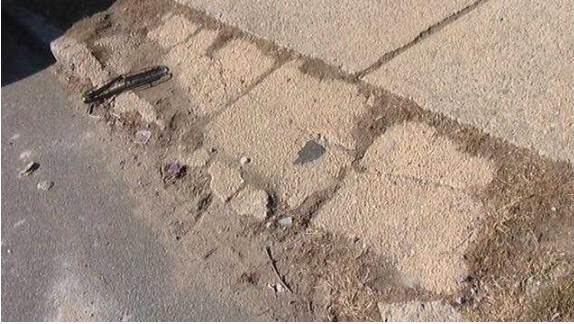
1. Driveway: driveway skirt has settlement damage - driveway also has settlement - driveway is pitching towards home

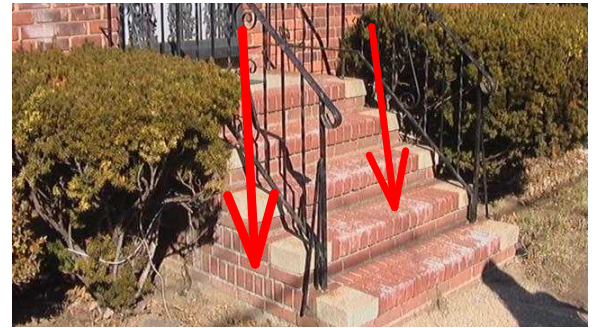
2. Front of home Steps To Building Steps brick major settlement

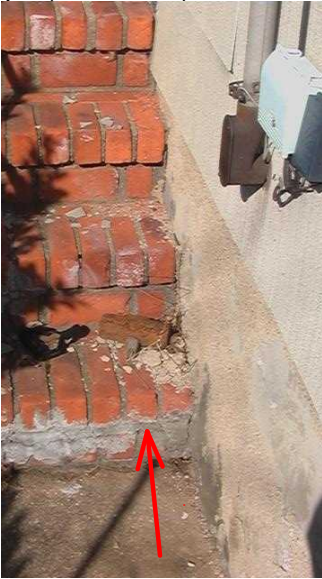
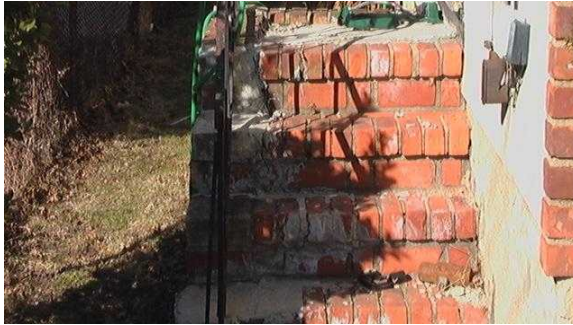
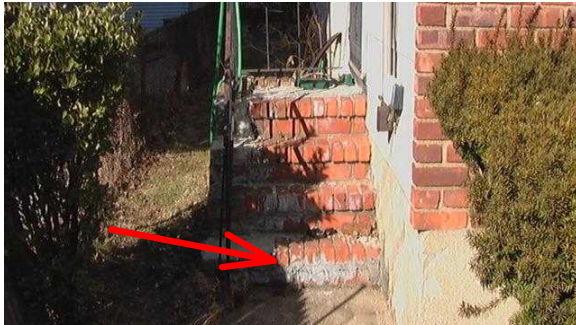
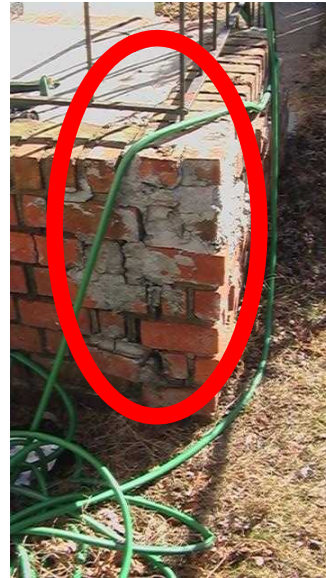
Steps (continued)

3. Side of home Steps To Building Steps brick major settlement

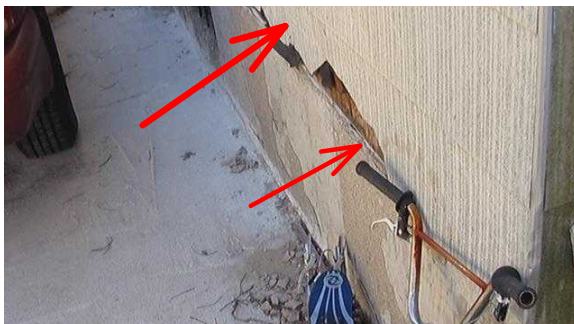
4. Front Exterior Surface Type: Brick veneer
5. Exterior Surface Type: Asbestos Shingles *asbestos shingles are loose and damaged, water is getting into home ..*

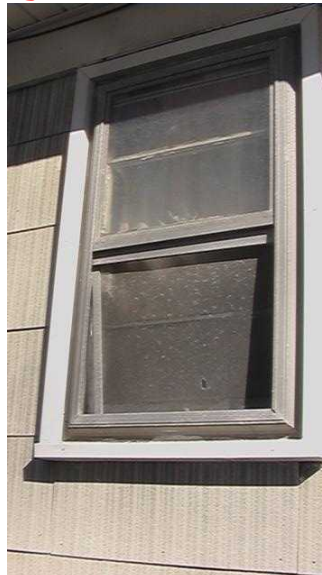
7. Windows: Wood double hung Cracked, broken or missing glass, windows are beyond there life span - all windows are leaking water thru inner walls

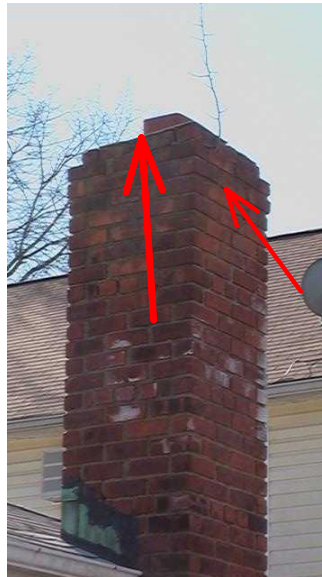
12. Rear of Home Chimney: Brick Chimney requires tuck point repairs, Bricks have broken or popped surfaces- repairs required - Chimney footing is damaged from settlement

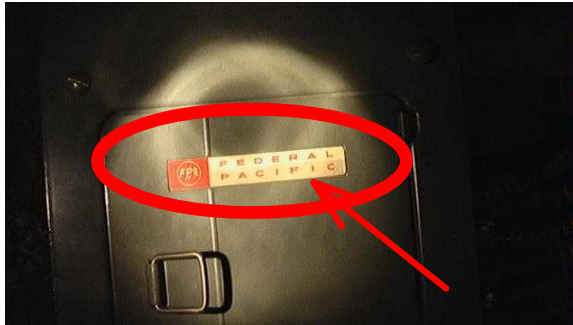
16. Electric Panel Manufacturer: Federal Pacific Federal Pacific panel breakers have a history of not tripping when circuit overloading exists

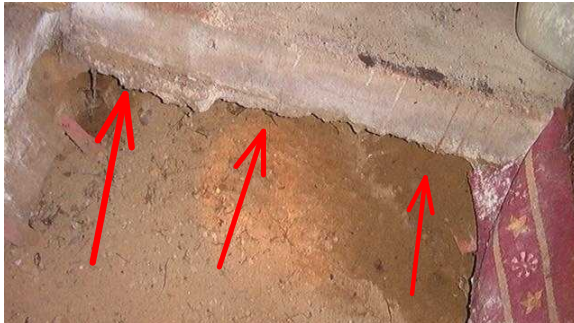
25. Main Basement Floor: **major water damage present , mold present - dirt under basement floor has wash away due to the sewer trap open caps. the basement floor is floating and needs support**

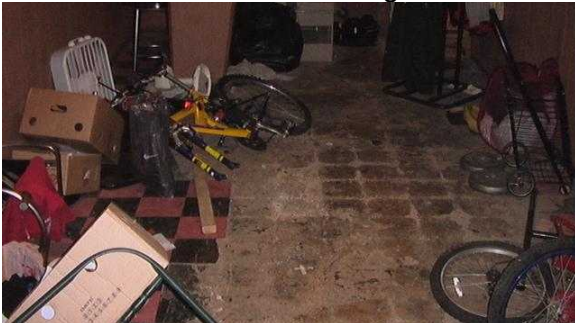
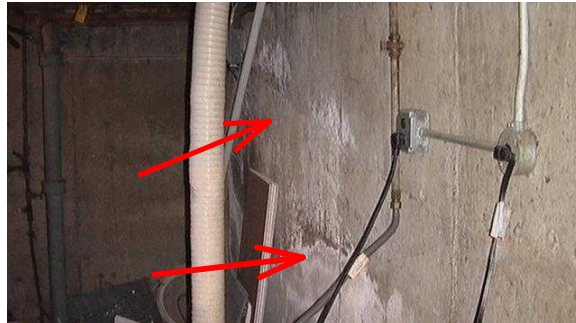
26. Main Basement Water Damage: **entire basement major water damage in basement**
